US Army Corps
of Engineers
Seattle District

Construction Foundation Report

Mud Mountain Dam Seepage Control Cutoff Wall

CONSTRUCTION FOUNDATION REPORT
SEEPAGE CONTROL WALL
CONTRACT NO. DACW67-83-C-0047

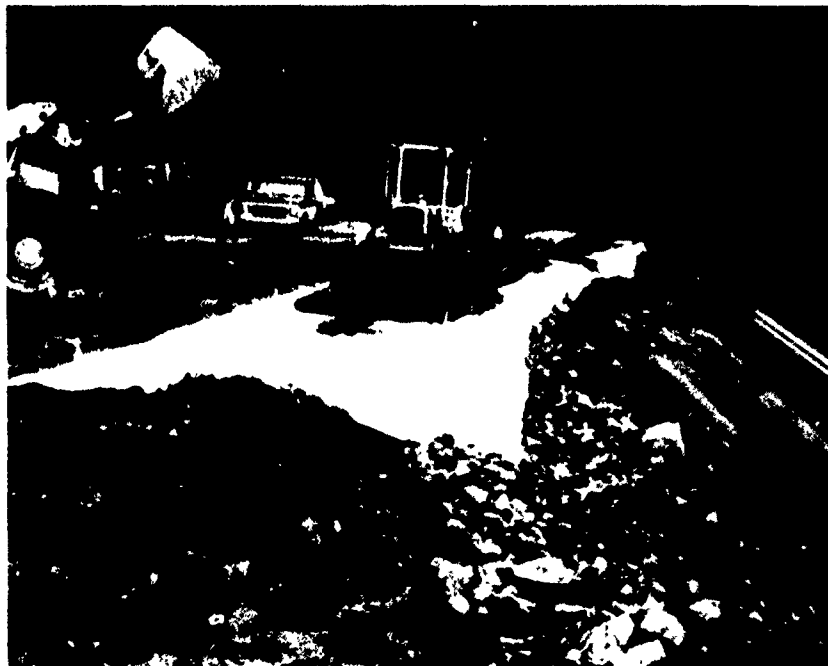
Geotextile placement on lowered dam work platform. 6" of base course material over fabric.

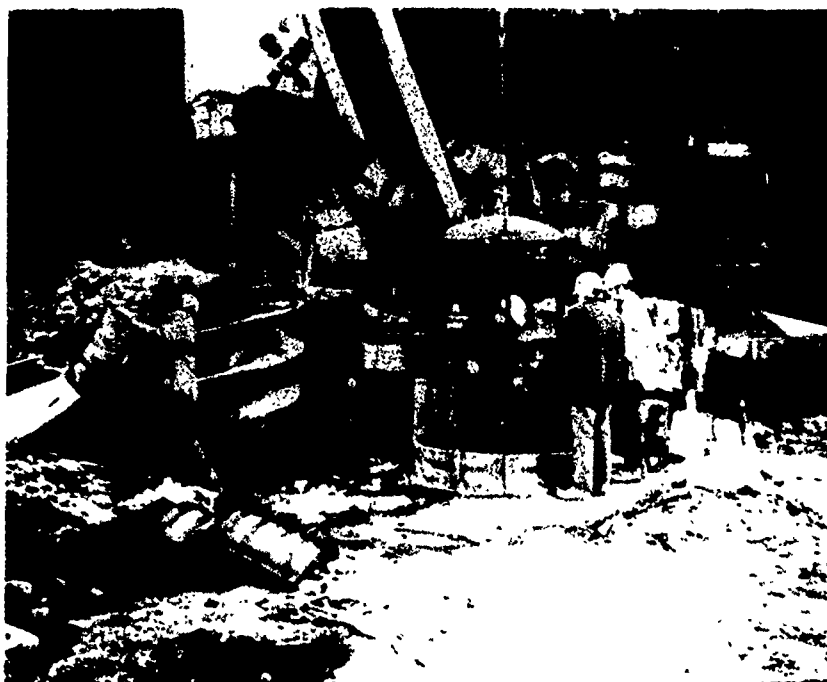
Inspector being lowered into access shaft with a man basket. Note liner plates, left.

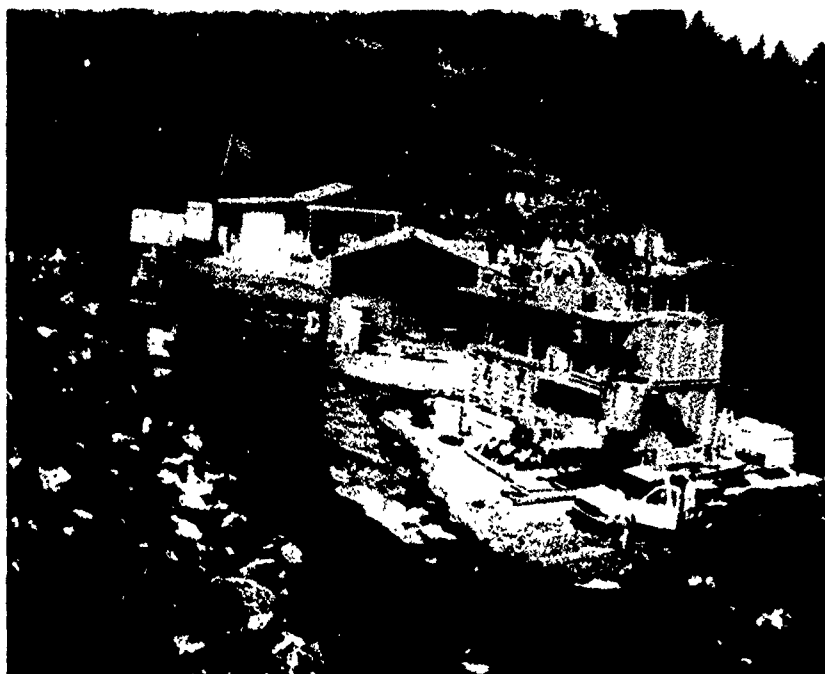
Looking at right side of spillway invert.
Desander (Caviem) at right, welding shop in
middle and machine/parts shop in background.
Note spillway access road at left.

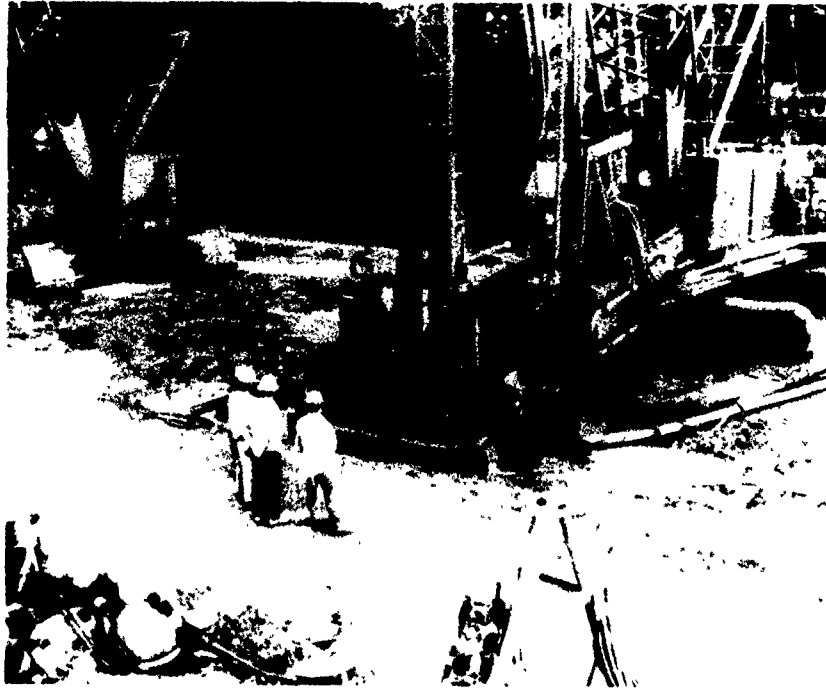
Hydrofraise excavating Type I panel in left back. Looking down stream. Top portion of hydrofraise frame is visible. Cutter heads at 75 ft. depth. Note guide frame on top of wall.

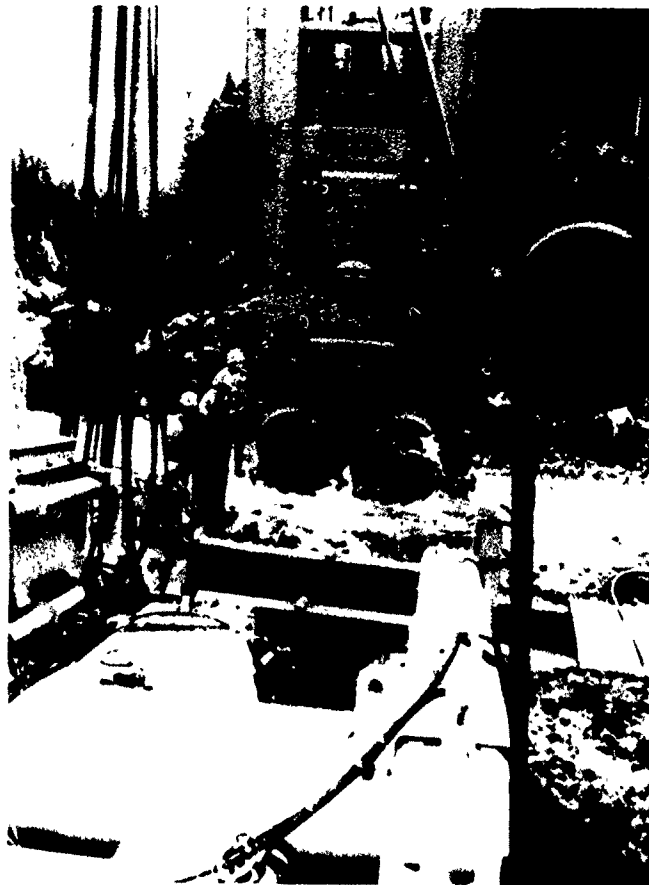
View of hydrofraise from operator's cab.

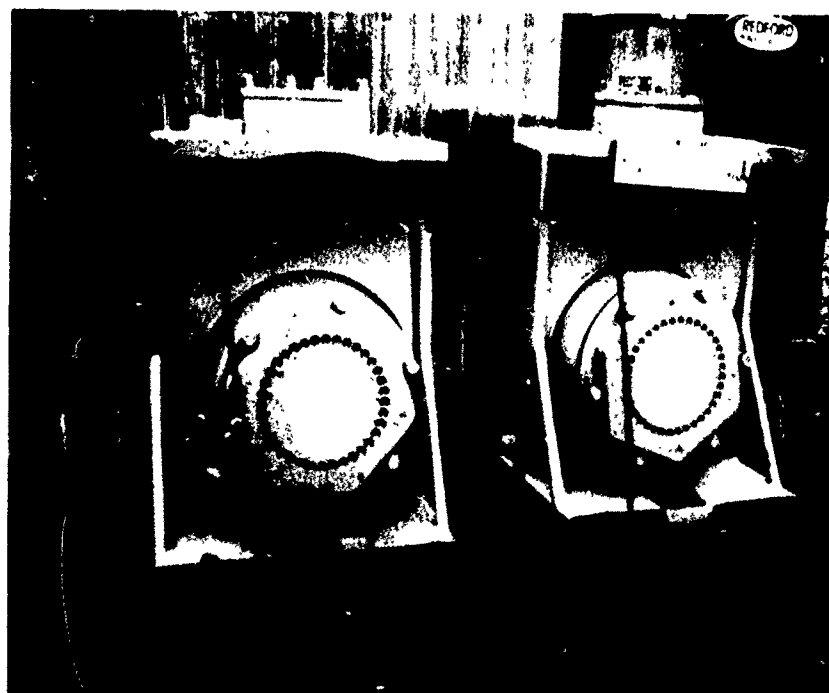
Spare hydrofraise motors.

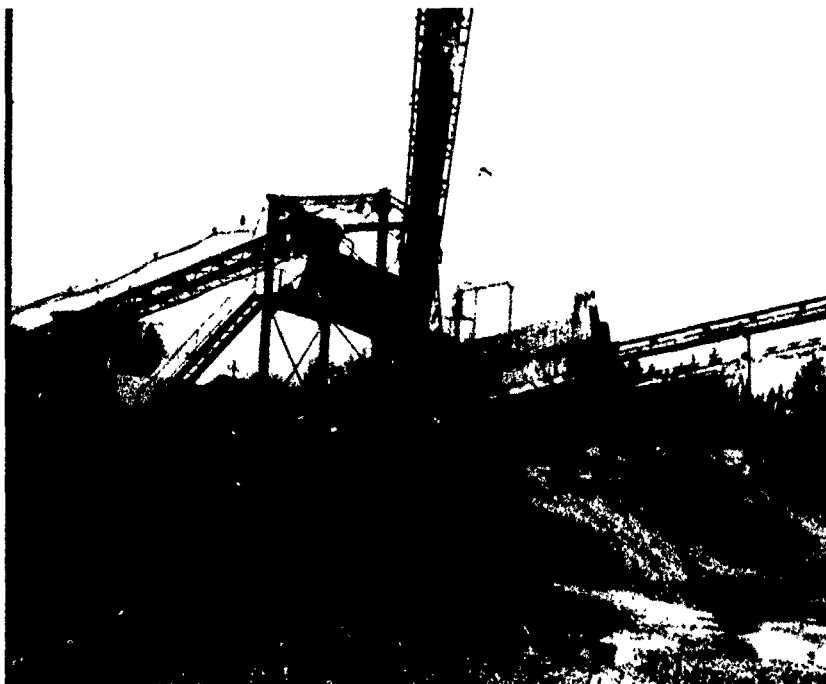
Cadman wash plant arranged to produce 1 1/2-inch, 7/8-inch, 3/8-inch nominal maximum sized aggregates and sand.

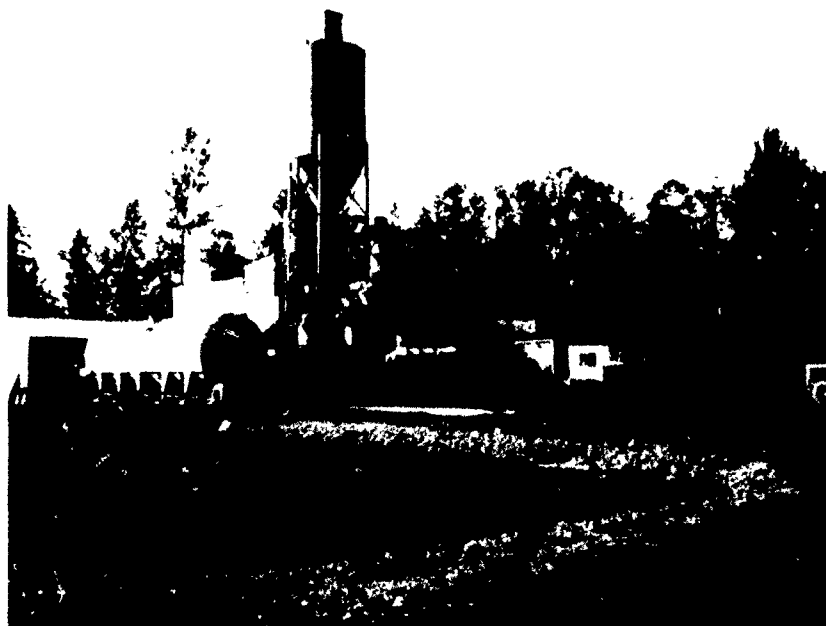
Batch plant with 115 tons cement silo, 100 tons pozzolan silo, and 175 tons storage guppy.

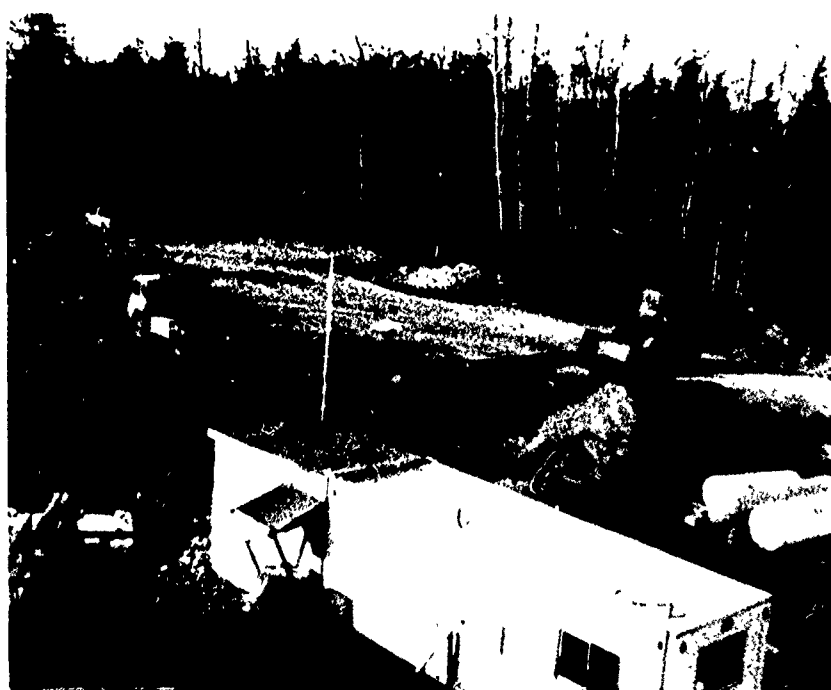
Winterization. Steel pipe arranged for the sand stockpile. The building is the contractor quality control laboratory.

c. The sand was used shortly after processing and delivery to the site. This material was holding an excess amount of water and wreaking havoc with the concrete slump. This problem was remedied by allowing the sand stockpile to drain for at least 24 hours before being used to achieve a constant condition in the sand.

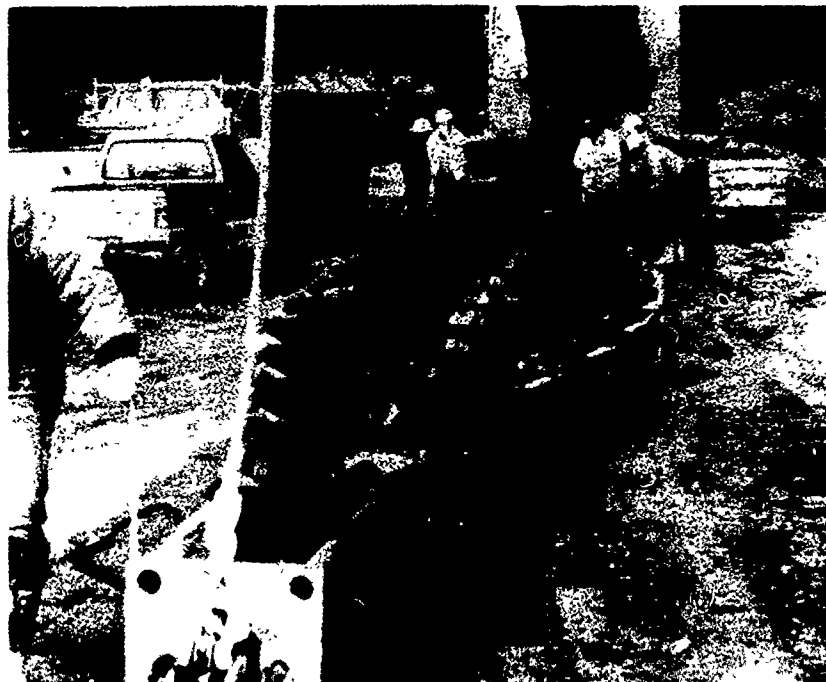
Coring "fish" viewed from top. Two of four drill pipes visible. Pipes radius outward then cross over at bottom. Cores .9 inch. Instrumental in early detection of panel verticality error.

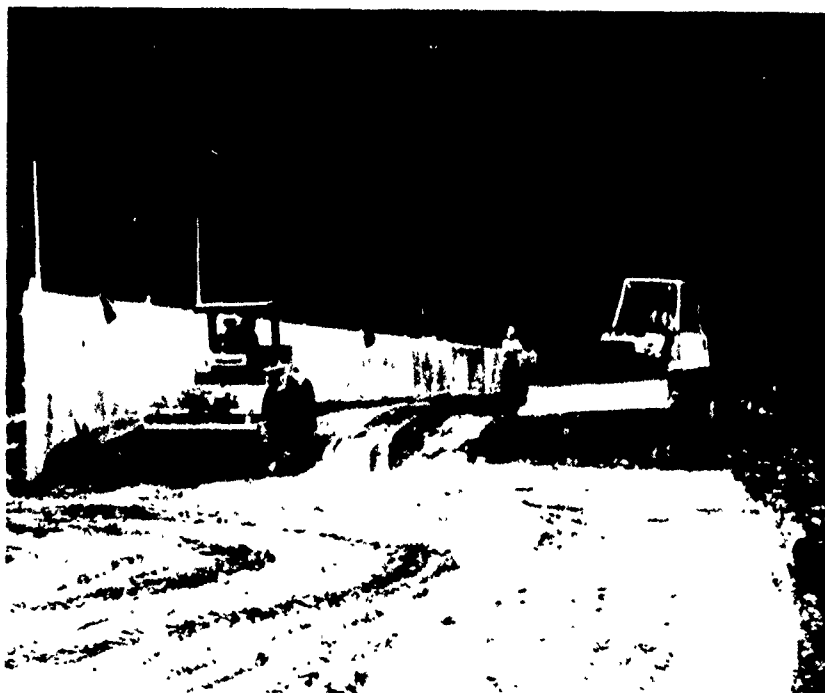
Backfill and compaction during dam raising. Thin strip either side of CIP wall was compacted with hand-operated tamper.
